**The National Barn
Alliance
February 15-17th
2013 Winter Meeting**
University of Mary Washington
Fredericksburg, Virginia

Houseworth Farmstead (Montpelier Estate), Orange County, Virginia:

Arlington Farmstead (Montpelier Estate), Orange County, Virginia:

Flintshire Granary and Corncrib, Caroline County, Virginia:

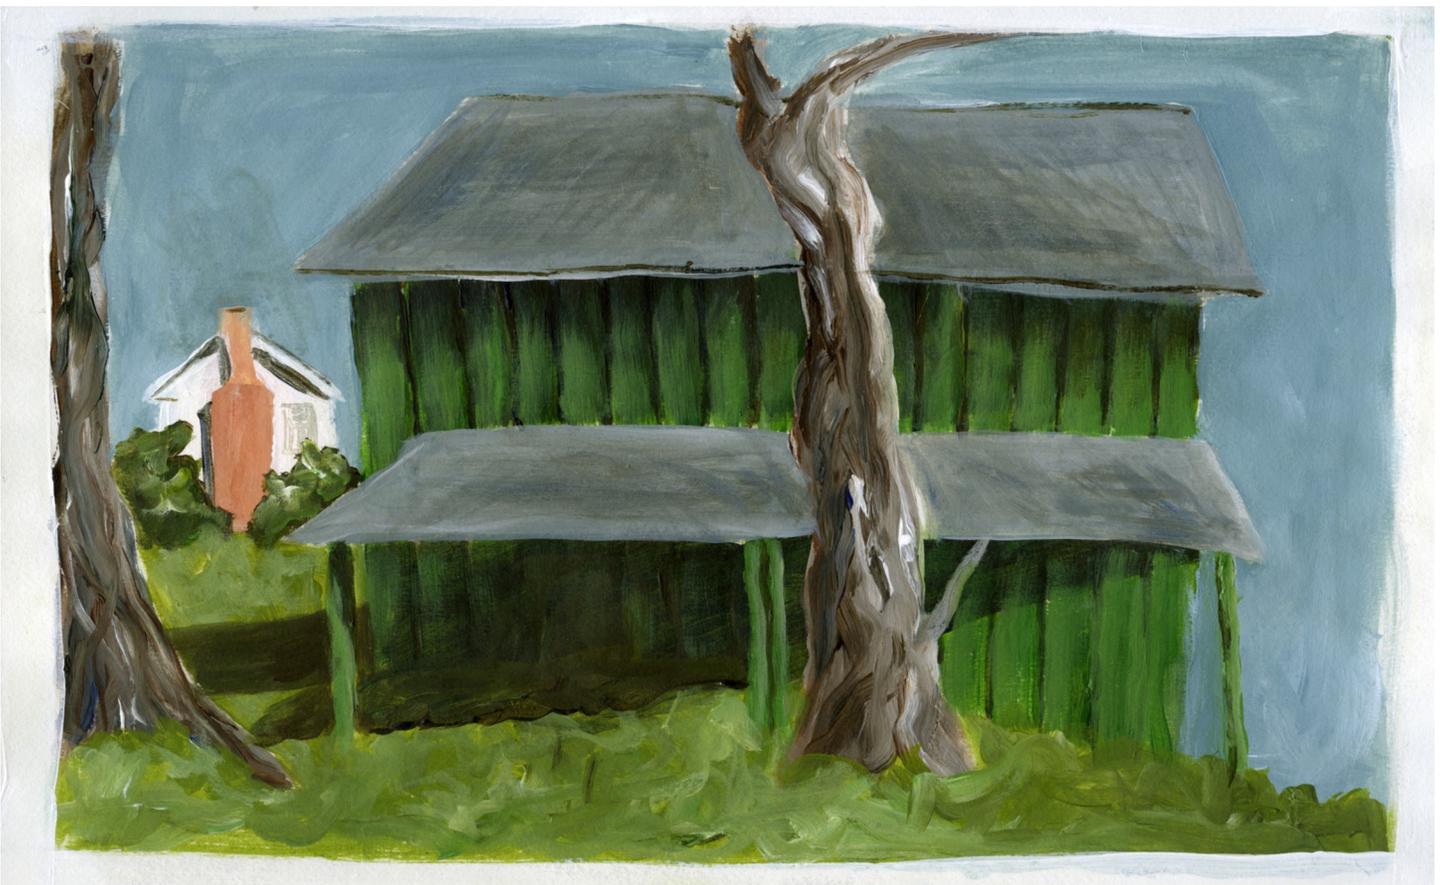
The artist rendering is of the carriage house at the Arlington farmstead, now part of the Montpelier Estate in Orange County, Virginia. (image drawn by Annie Lynch, 2012)

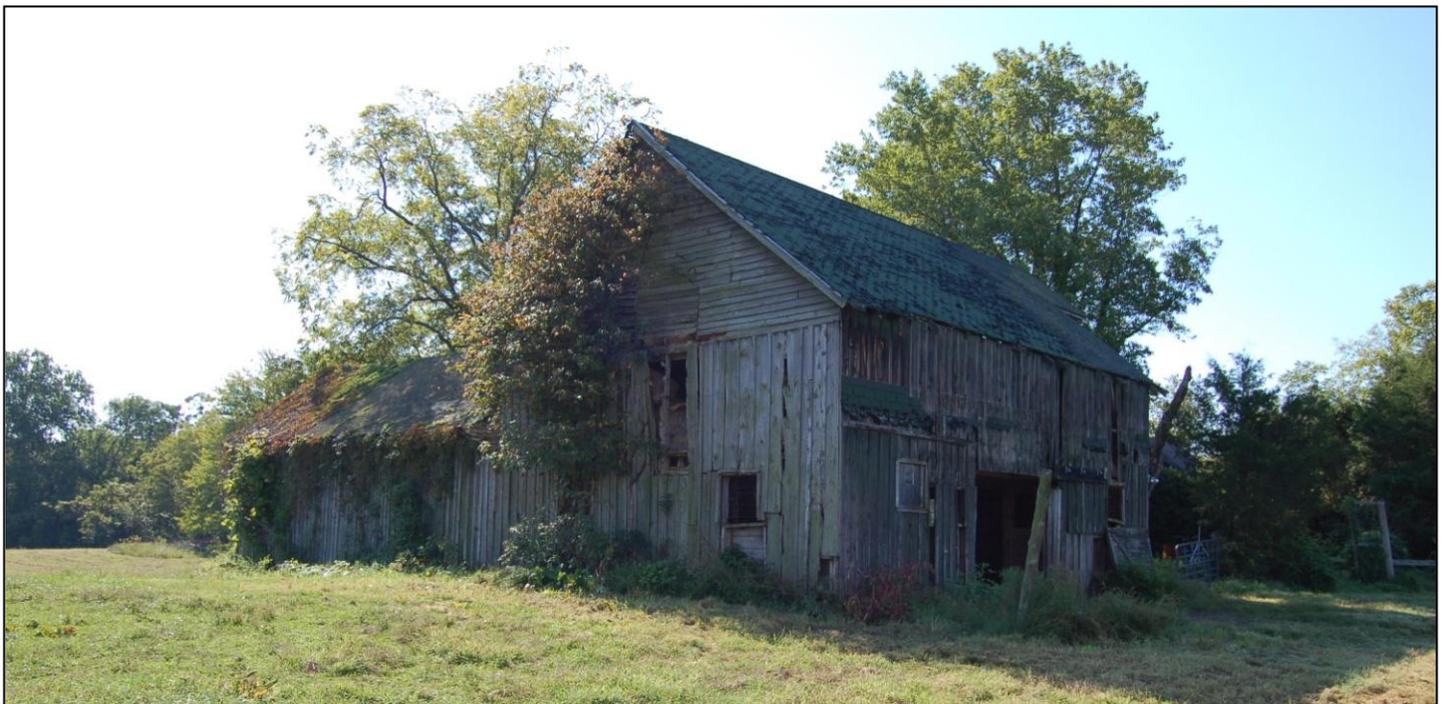
Fig. 3: The image shows the southwest perspective. At left is the rear ell. The hay hood is located on the other gable end (east elevation) of the barn, not visible in the image.

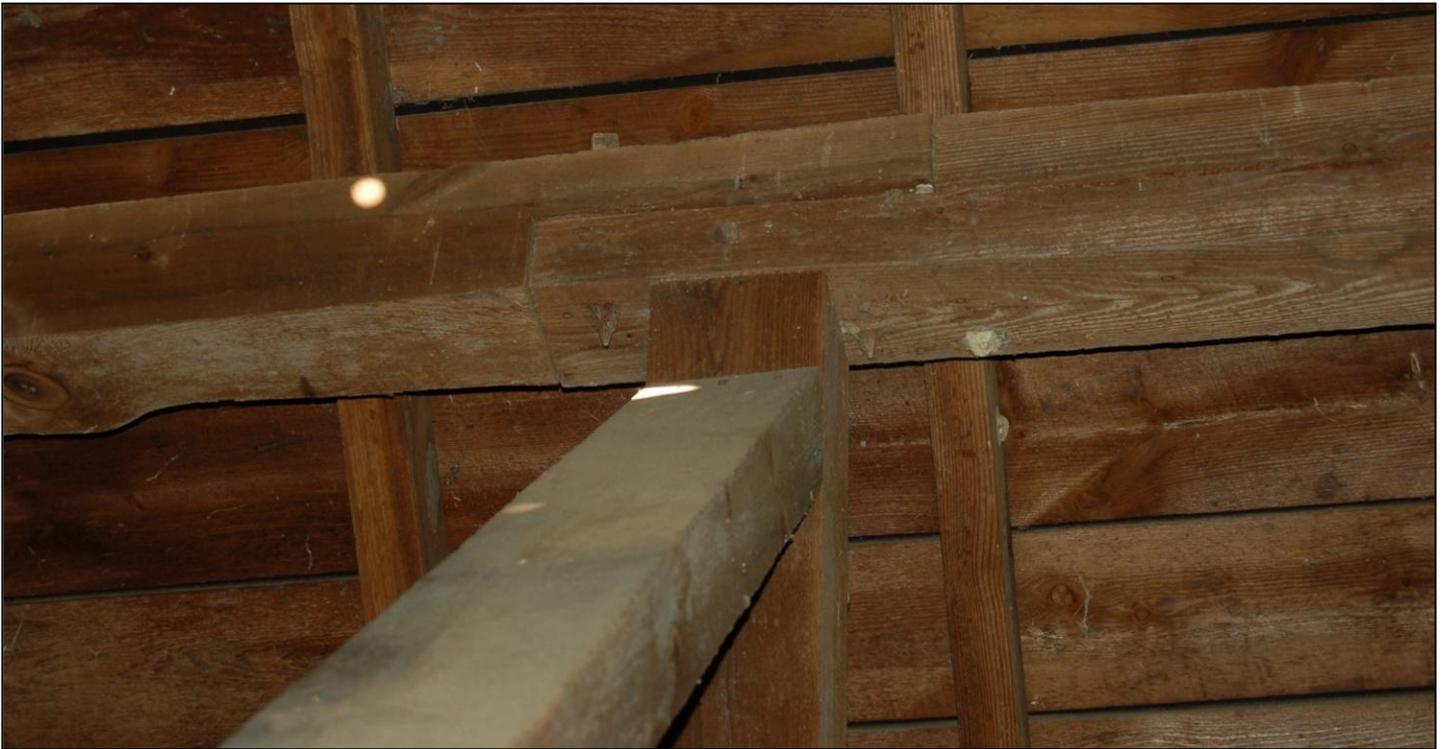
Fig. 7: The image above shows where a down brace intersects with a post and roof purlin. Note the lap joint placed directly above the vertical support and the tree nail protruding from the top and bottom of the joint.

Construction of the barn follows conventional timber-framing techniques with the various white oak posts and beams secured by mortise and tenon joints pegged with black locust tree nails. Lap joints are also present on both the purlins as well as at the peak of the common rafter system. The noted wood species are commonly found throughout the property and would have been in ready supply during the mid-to late-19th century. These members are arranged in a set of four bents spaced approximately 13’-4” apart. The bents themselves are set atop a wood sill which in turn is set upon a raised continuous stone foundation. Also in keeping with earlier construction methods is the variation on a queen post truss systems seen in the hay loft.

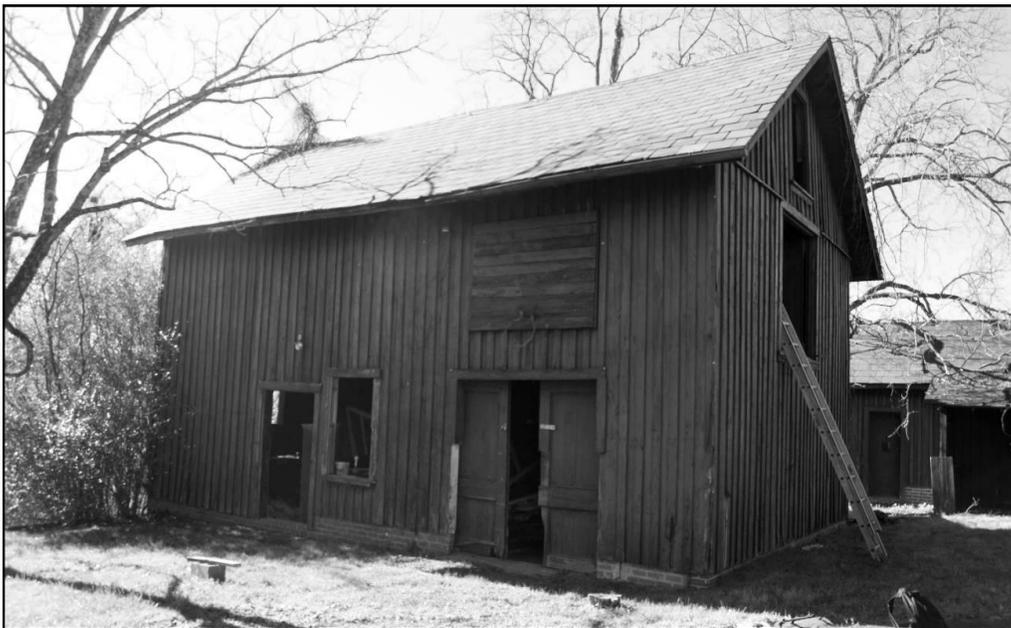
Fig. 10: The east elevation of the structure is clearly shown in this image. The two sliding doors, partially open indicate where the carriage would likely have been kept whereas the door and window lead into the stall area. On the north elevation the opening to the hay loft is discernible.

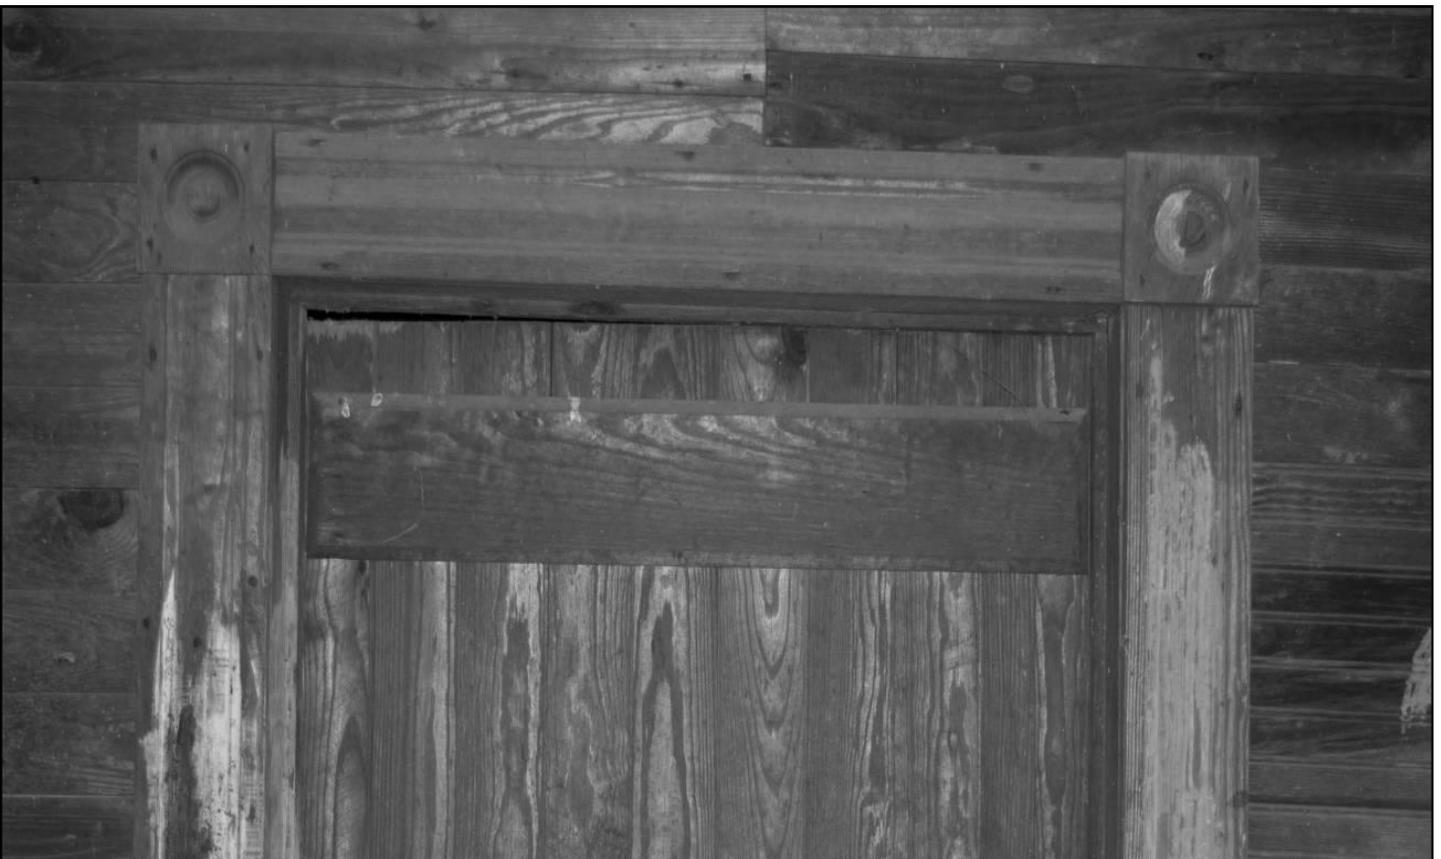
Fig. 12: Interior details of the carriage house consist of bead board as well as door trim complete with corner “bull’s eyes” or patera.

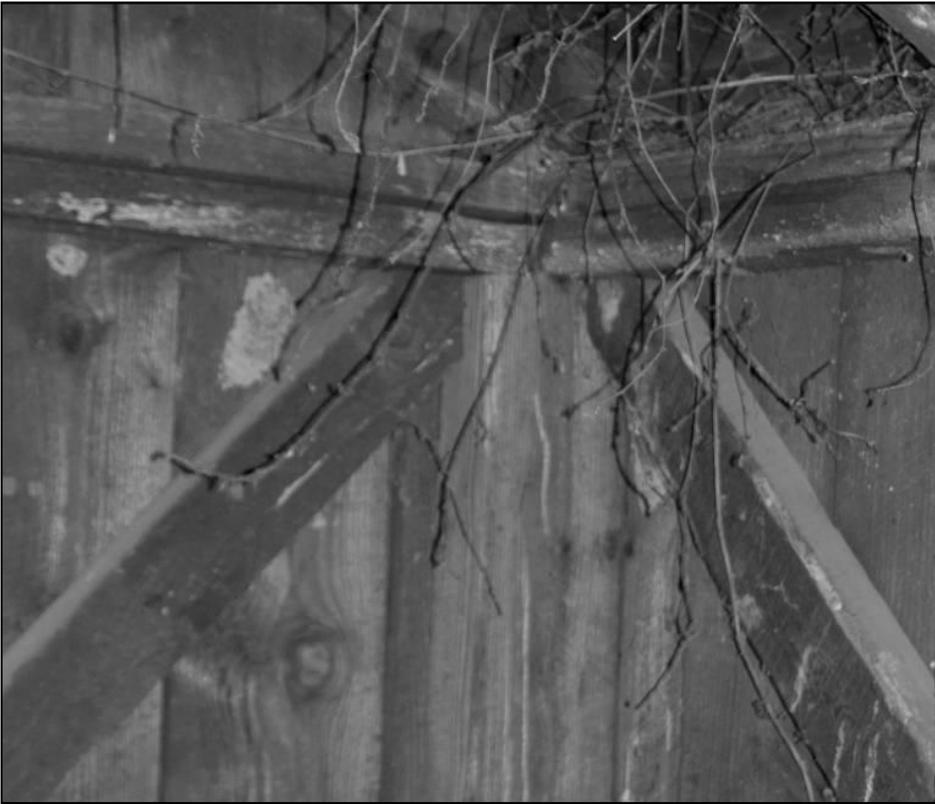
Fig.15: This image shows the down bracing used at the corners of the structure in the hay loft area. Note how the wall plate is two distinct pieces of lumber rather than a single large timber as often seen in timber framing. (2012)

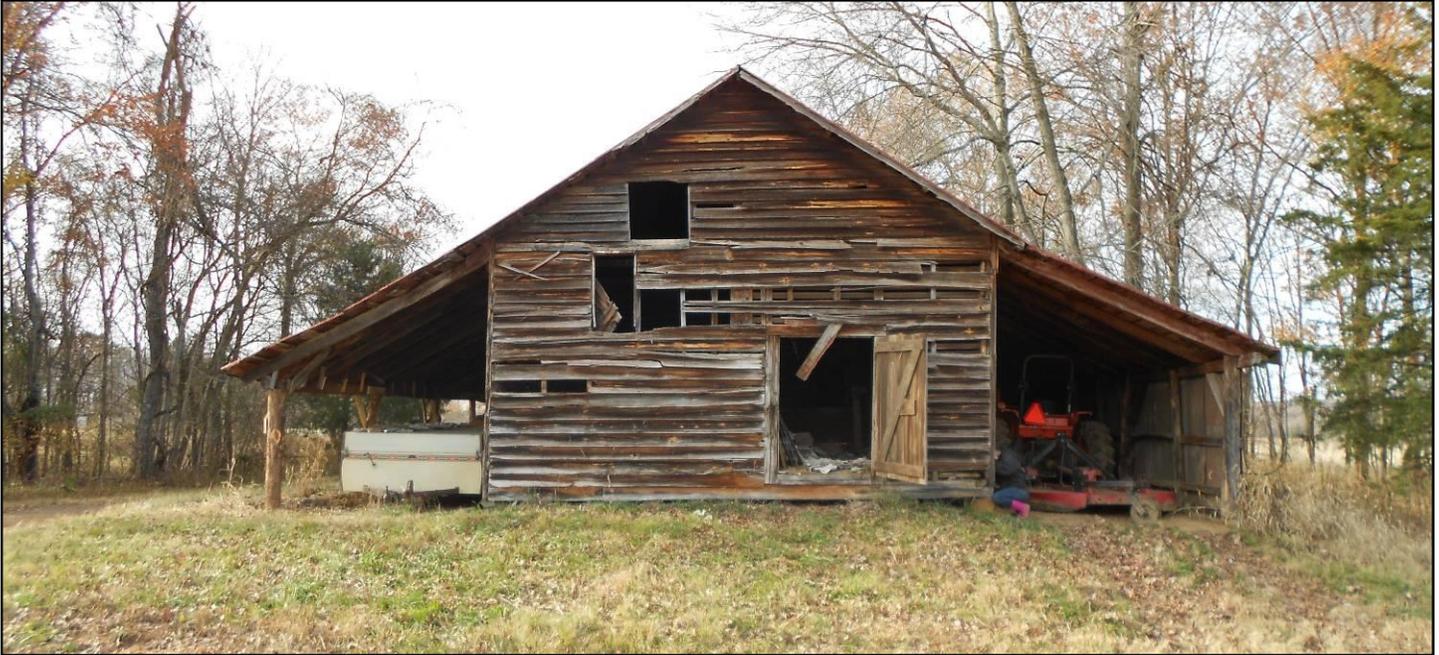
Fig. 22: The east elevation of the Flintshire corncrib. The opening at the top would have allowed for the loading of the corn. While the structure appears to be one large crib it is actually divided into two separate storage areas, likely to promote drying and air circulation. (Image, 2012)

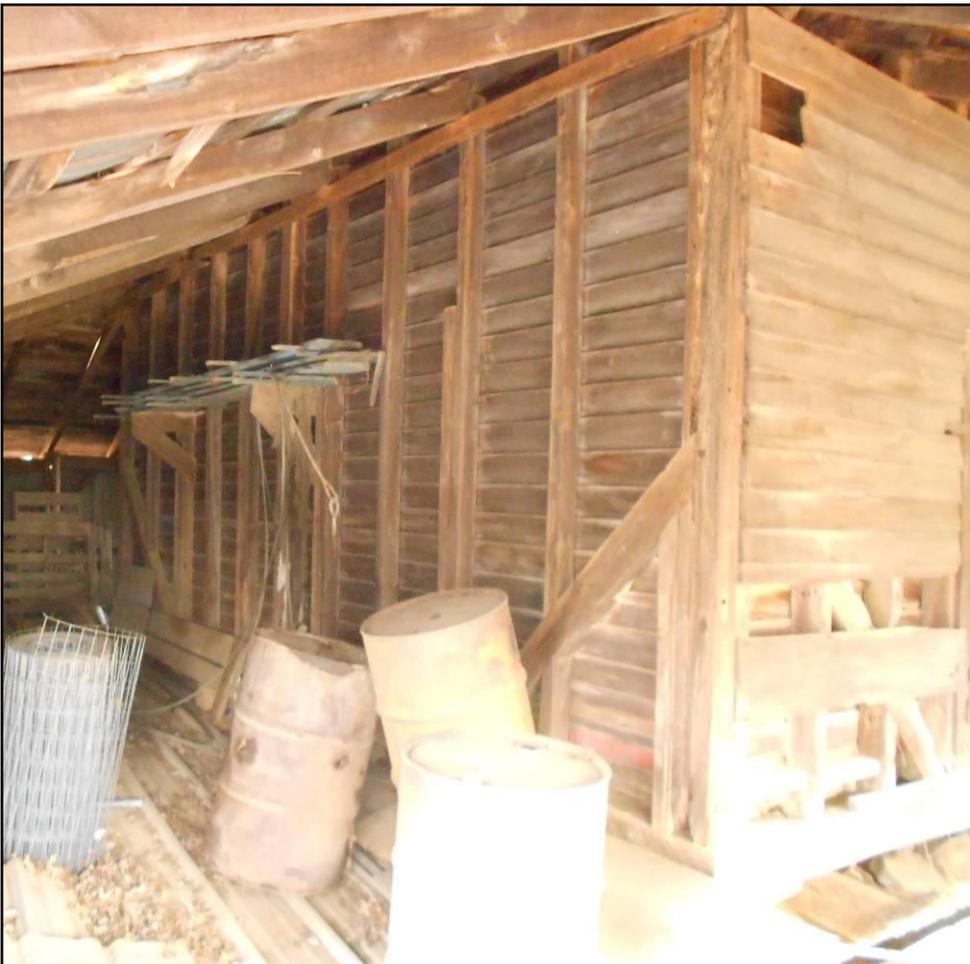
Fig. 23: This image shows the southwest corner of the granary which is adjacent to the corncrib. Note the down bracing as well the interior wood siding, likely to secure the grain. The visible studs have no siding due to the fact that the structure originally had a shed roof projecting from this area and so additional protection was not necessary. (Image, 2012)

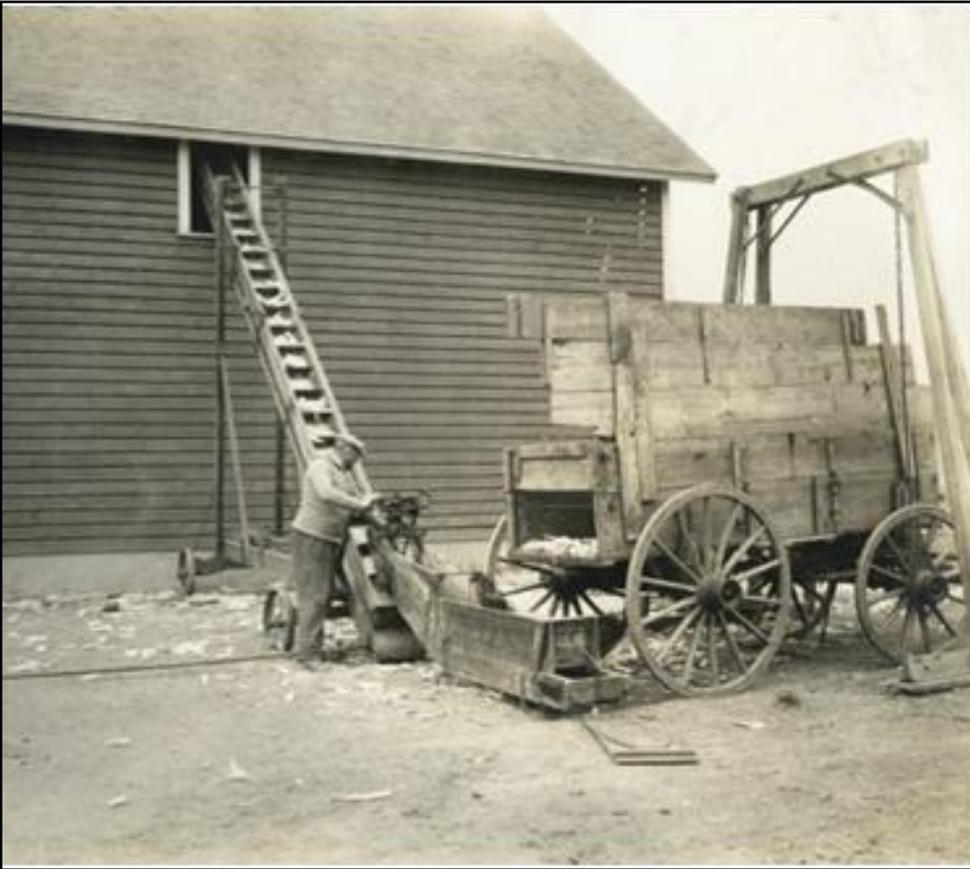
Fig. 24: Early 20th century image showing corn being unloaded from a wagon and place in an elevator which then loads it into the corn crib.

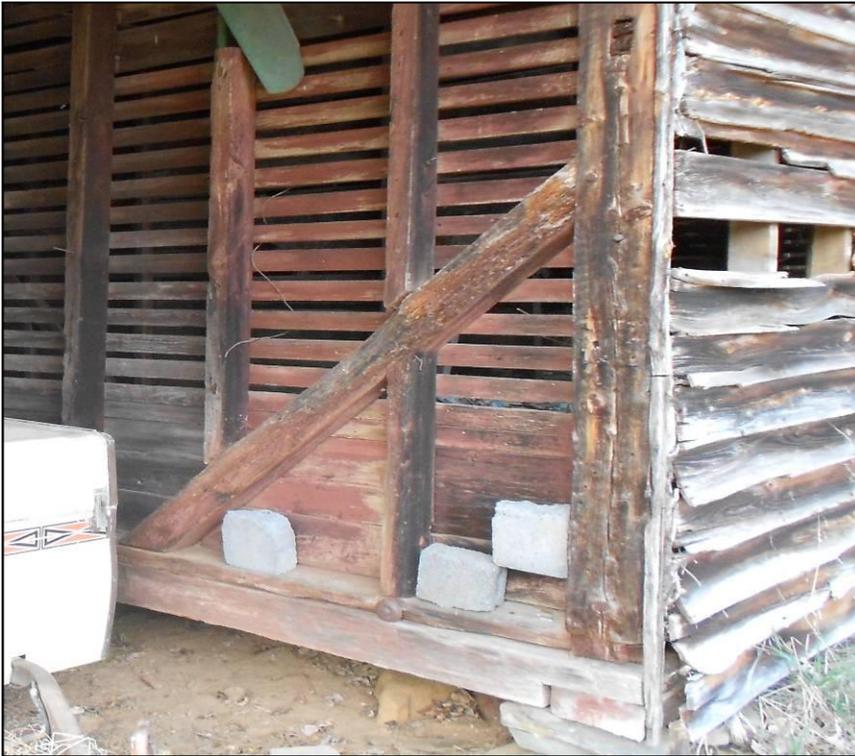
Fig. 26: The southeast corner of the corncrib showing the down bracing as well as the ventilation slats. Note the hand hewn sill at the bottom as well as the large corner posts with "ghost" mortise (upper portion of the corner post).

The granary and corncrib sit side-by-side at the northeast end of the Flintshire farmyard. Wrapping around three-quarters of the structure, on the north, east and south elevations, is a post-in-ground, lean-to addition. Like many corncribs and granaries the Flintshire structure is raised on stone piers to assist with ventilation and to help deter rodents. Placed across these stone piers are hand-hewn, white oak sills. Typically found in older structures, the sills of the corncrib and granary were likely re-used from a previous building. Further evidence of re-use can be found in the large pine corner posts which show a number of "ghost" mortises. While such joinery indicates previous use, a number of mortise and tenon joints can still be found performing their intended function. This includes the corner posts and white oak studs which are all tenoned into the large sill. The sills themselves are connected with simple lap joints with the tenon of the corner posts securing their position. Down braces, mortised into each corner post and secured with black locust tree nails, provide additional structural rigidity and support.
