# The Barn Door

## Re-Raising the Star Barn

## Dating Barns in Holland Township, New Jersey with Dendrochronology (Part 3)

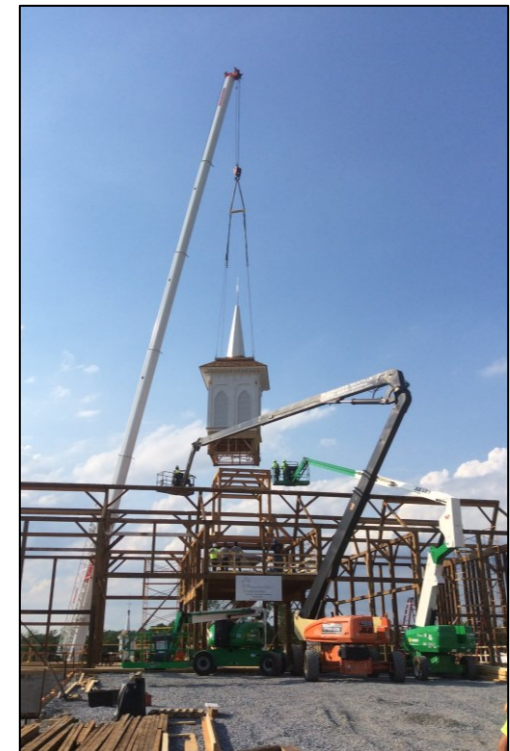
*Reuniting the cupola and historic framing, July 2017, Photo Credit: Charles Leik.*

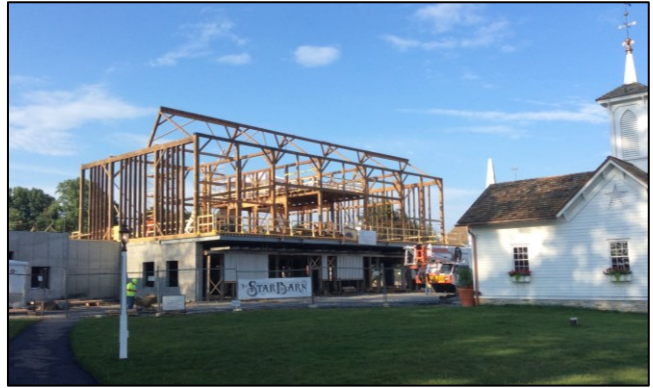
*Image of Original Frame on New Site and Foundation with Relocated/ Rehabbed Outbuilding at Right. Photo: C. Leik.*

The Star Barn has a canted purlin roof system and the first of these was also installed on July 3. A crowd of perhaps two thousand appeared on the 4th of July to witness the dramatic raising of the Gothic steeple by a massive hydraulic crane. This was completed in the late afternoon as a storm threatened with several timber framers riding a hydraulic basket to secure the mast. At 9 p.m. just before the fireworks, the framers dramatically rode the basket again against a night sky to install a fleur de lis and weathervane to the steeple’s pinnacle. Of course, much remained to be done by Trillium Dell in the following weeks but it was a great end of the Fourth of July holiday and a great beginning for the Star!

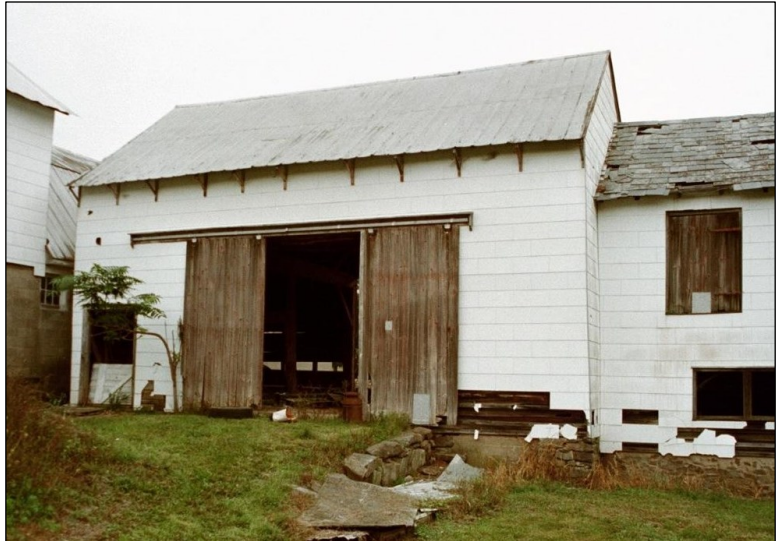
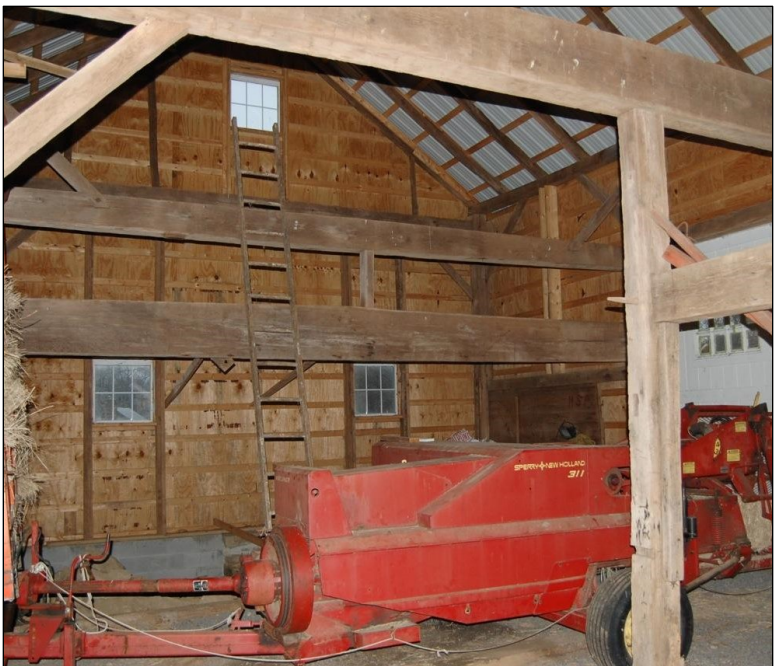
*Top: View of Hammerstone Barn in Holland Township, NJ  
Bottom: Interior View of Swing Beam and Other Framing Members,  
Hammerstone Barn. Photo Credit: C. Cielo.*

After dating six other ground-level, swing beam barns that ranged in date from 1794 to 1812, the 1787 date was questioned. The character of the framing of the Hammerstone Barn looks far more advanced (younger) in its construction methodology than barns that dated to the 1790s. For example, the interior bents of the 1794 James Salter Barn are framed with just two unconnected cambered tie-beams. Whereas in the Hammerstone Barn, struts and passing braces are incorporated into the swing beam bent to join the upper and lower tie beams. This is characteristic of the ground barns that dated after 1803 in Holland Township. It was therefore decided to date the barn again using a professional dendrochronologist who operates his own in-house lab. The findings were interesting to say the least.

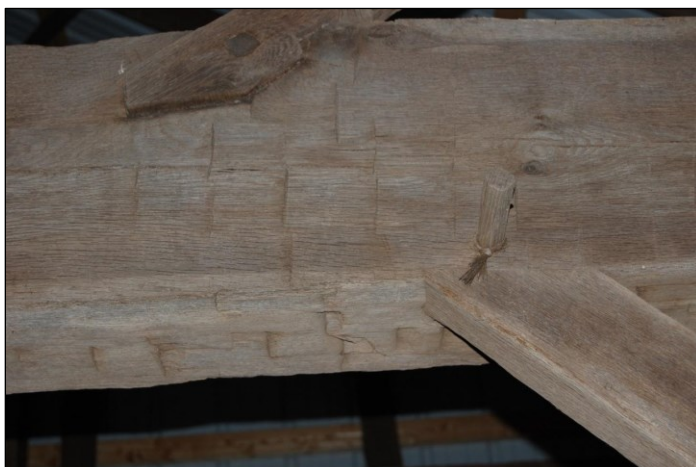
*Detail of Bracing Joints at Swing Beam (left) and of Sample Extraction (below). Photo Credit: C. Cielo.*

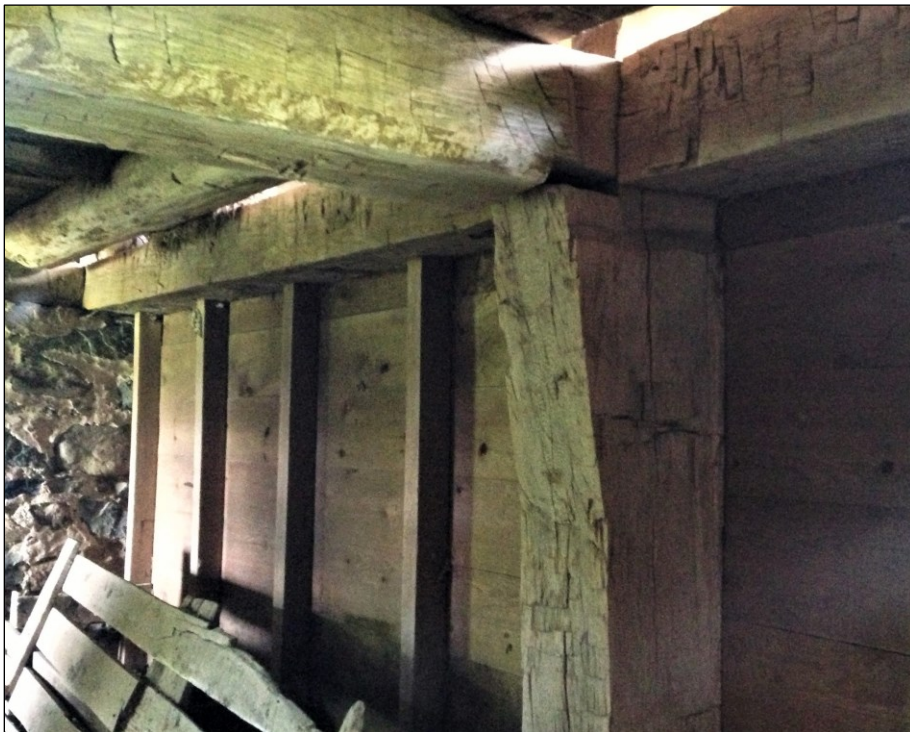
The image below would not necessarily turn a head if it were taken in New England, or New Jersey, or Pennsylvania. But this is Southeast Michigan. And having been in hundreds of Midwest barns I can count on two hands how many times I have seen flared posts; and I still have fingers left to count with. This is all the reward any barn detective could ask for; to find something that is not common to the area in which it is located and then to try to understand why it is there. This particular pre-Civil War barn is a stunning 40 by 50 three-bay barn in central Washtenaw County, that happens to have been built by a barnwright that still understood the English tying joint that informs the configuration. This post is found at the top of the basement framing. The detail is part of a full-height basement, which is not uncommon in Michigan barns. But they typically have a bank. This barn however cannot be called a bank barn; there is no evidence it ever had one.

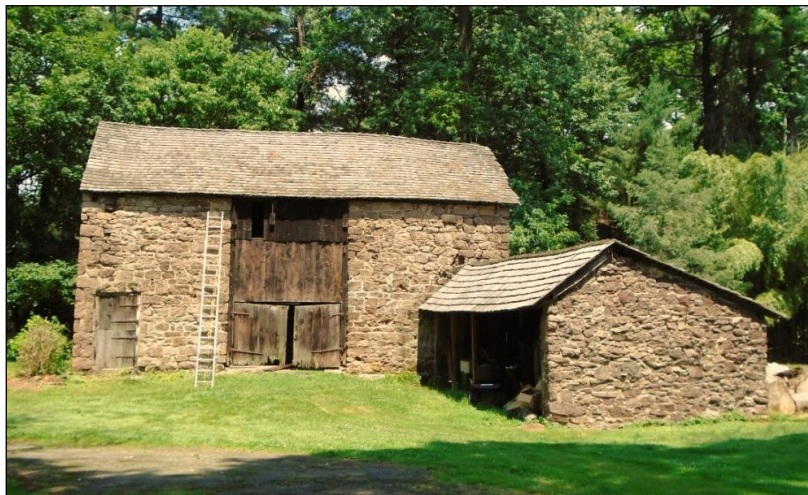
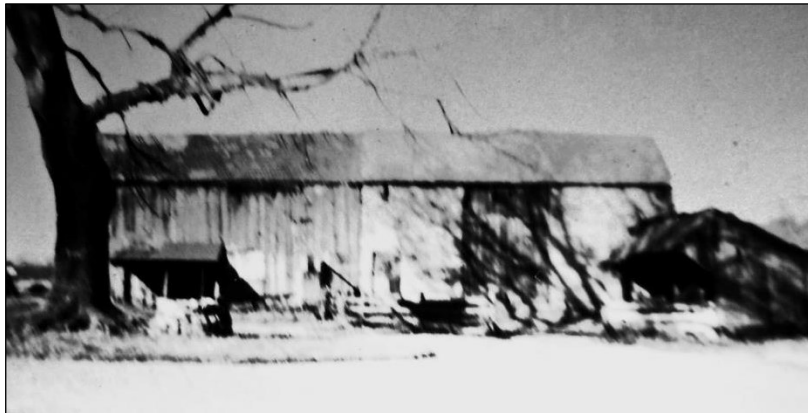
*November 1947 photo showing frame addition on west gable end (top) and Front of barn (at bottom).*

This barn measures approximately 40' wide by 24' deep. It is three bays wide but the bays are not all the same width. The westernmost bay with the door on the south elevation is approximately 13' wide, the frame central bay is just over 11' wide and the easternmost bay is approximately 15' wide. Unlike some similar barns, there is no door on the south elevation of the eastern bay (obscured by a stone shed). The entrance to this bay is from the east gable end.

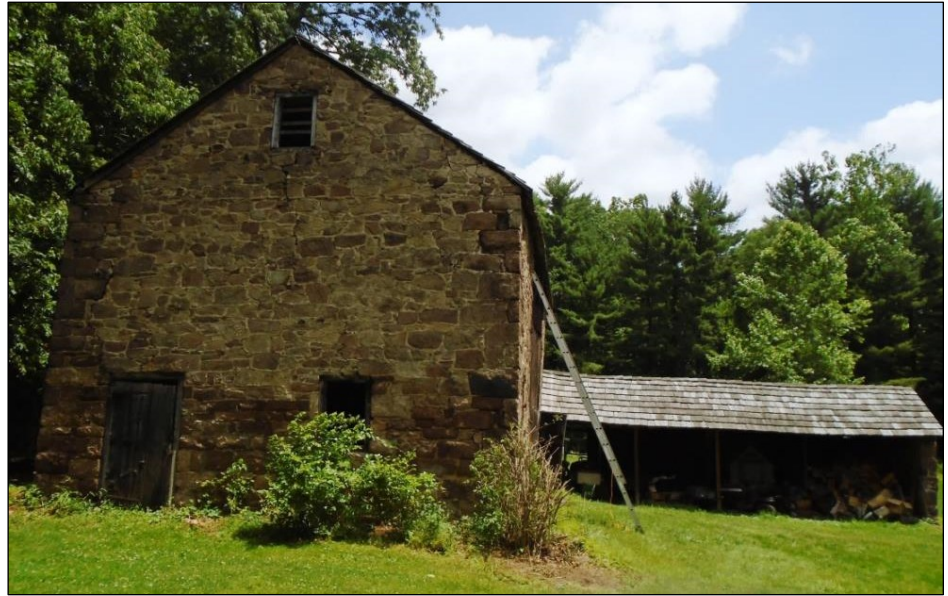
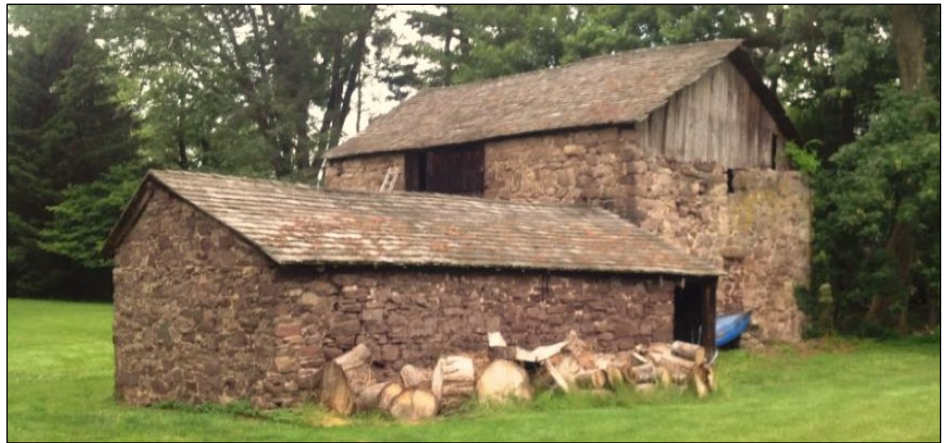
*View of east gable end and shed. (top) and west gable end (right).*

Currently the east gable is covered with wood siding. The amount of stone lying around the barn suggests that it was originally stone to the peak as is found on the west gable. The interior of the barn maintains its original three bay configuration.

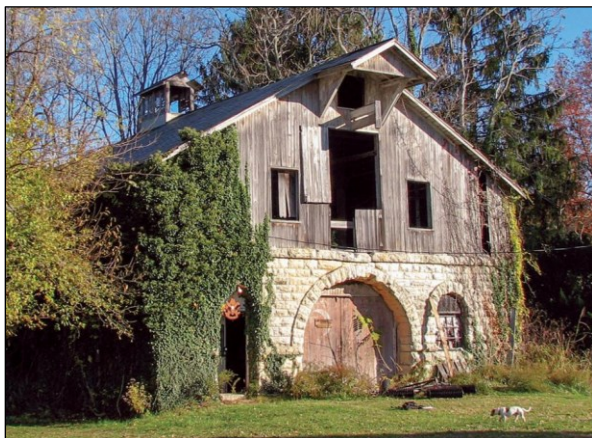
*The foundation of the Cravenhurst barn is made of cut and dressed stones with arched entry to a central drive at the lower level. Photo credit: Indiana Landmarks. To learn more, visit: <https://www.indianalandmarks.org/endangered-property/cravenhurst-barn/>*

Indiana Landmarks, the non-profit preservation organization for the Hoosier State has also named a barn to their 10 Most Endangered listing for 2018. The Cravenhurst Barn, located outside of Madison, Indiana, is a 1906 bank barn that is unique in the area. It was highlighted as one of Farm Journal Media’s Great American Barn series in 2016 and features an internal silo, collapsing now, and feeding chutes to main and lower levels from the grain storage floor above.

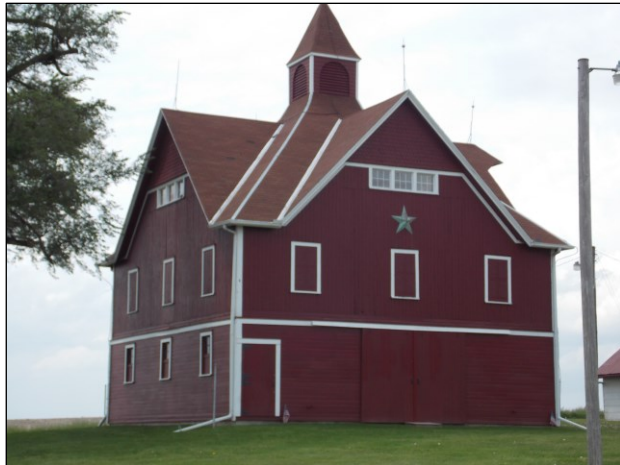
**The King Barn (Left)**

Built in 1898. This is one of six "Cross-Gable" barns still standing in McDonough County. These Cross-Gable barns were mostly built by one builder, Newt Willis, who popularized this local style with its open hay loft and their huge ventilating cupolas.

**The Flack Barn (Right)**

This double valley Cross-Gable Barn was built in 1900 by Newt Willis. This farm has been in the same family for over 155 years. The great grandfather of the current owner lived on this farmstead. The exterior has recently had a complete restoration with its original color scheme to maintain its historical sense of time.

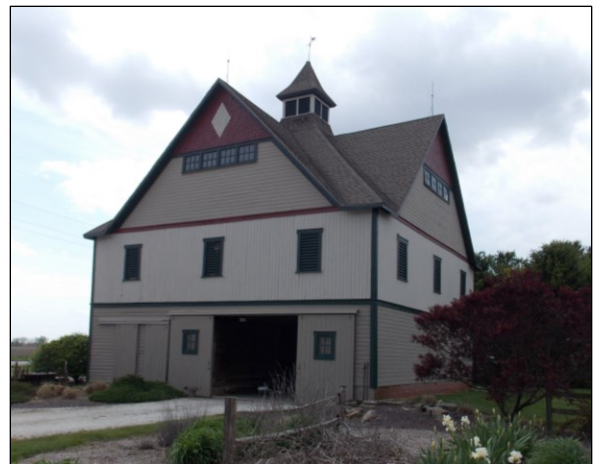
**The Kipling Barn (Left)**

Built circa 1920. Originally this barn was built as a general purpose barn for the farm. In 1944 it was converted to an egg laying house for hens with a third story added for greater egg production. The barn features an internal grain elevator. Currently the barn is no longer in egg production, but is used for family storage.

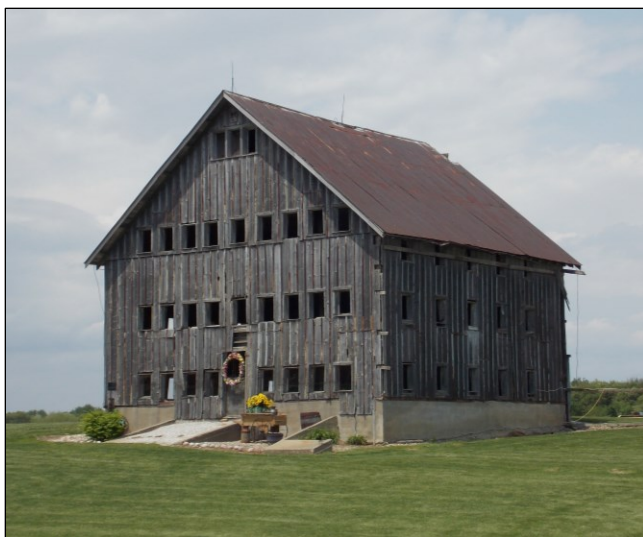
**The Redman Barn (Right)**

This "Cross- Gable Barn" was built by Newt Willis in 1895. This is the oldest of this barn type still standing in McDonough County and is listed as a historic landmark. One of the interesting features of these Cross-Gable Barns is the owners liked to use more than two paint colors to cover the exteriors.

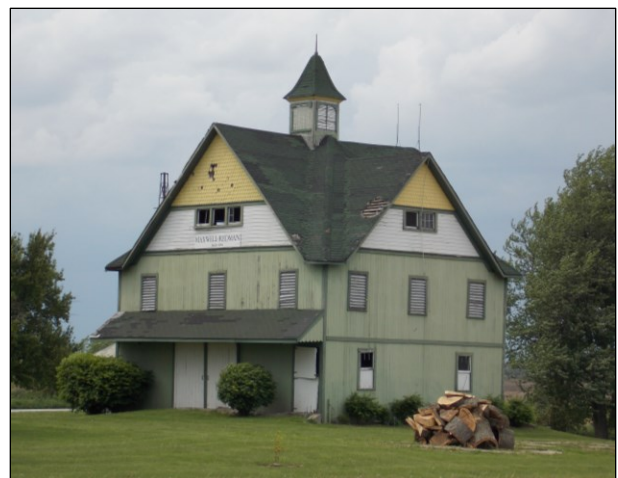
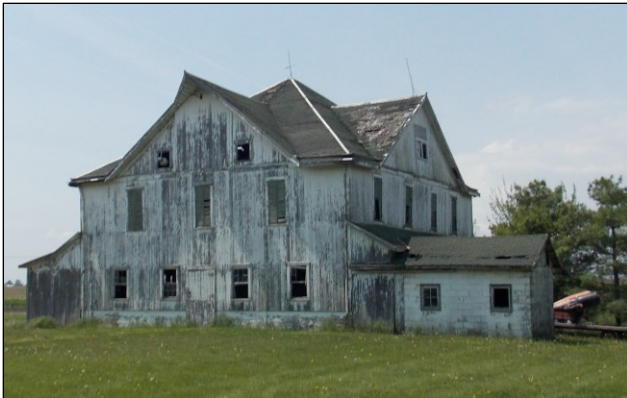
**The Penington Barn (Left)**

This Cross-Gable Barn was built by Newt Willis and Nick Breasaw circa 1900 - 1915. It has the familiar open hay loft like all of these barns. No doubt is McDonough County is the hearth area of these cross-gable barns. Note on this barn there is no ventilating cupola. It originally might have had one to vent the heat of the hay mow. It might have blown off or might have deteriorated and been removed during a reroofing job...

**The Everly Barn (Right)**

This Stick Style horse barn was built in 1882 by Newt Willis. It is listed on the National Register of Historic Places. The multi-color scheme is even included within the horse stalls of this barn. The fretwork and ornate trim make this a unique barn in Illinois.
